SAN DIEGO CIREN

June 21, 2001

The San Diego CIREN Research Project

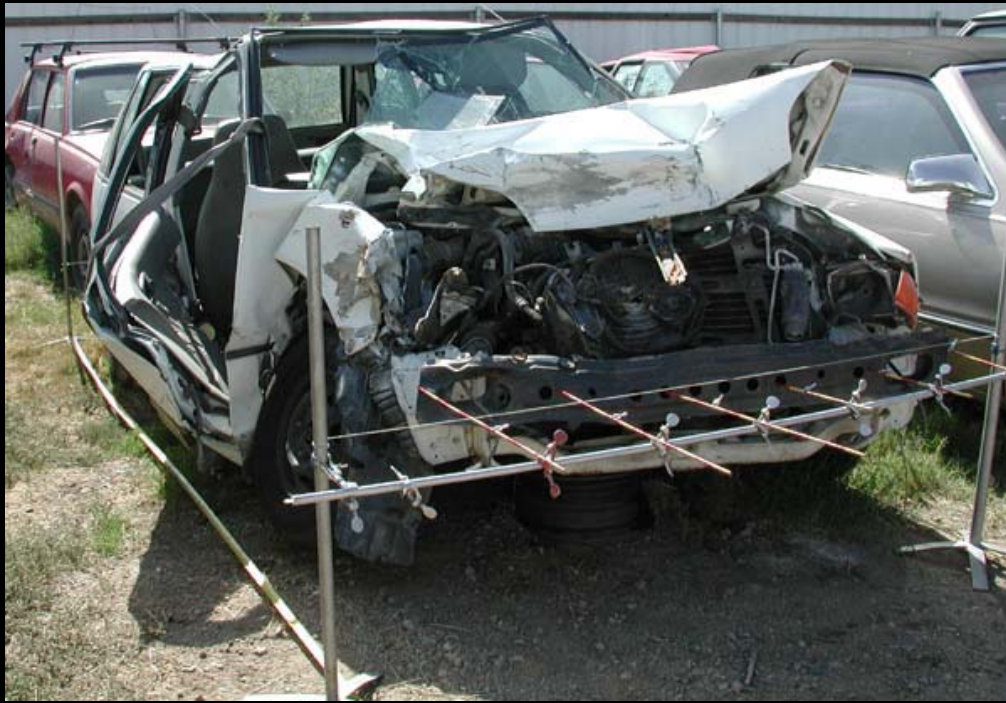
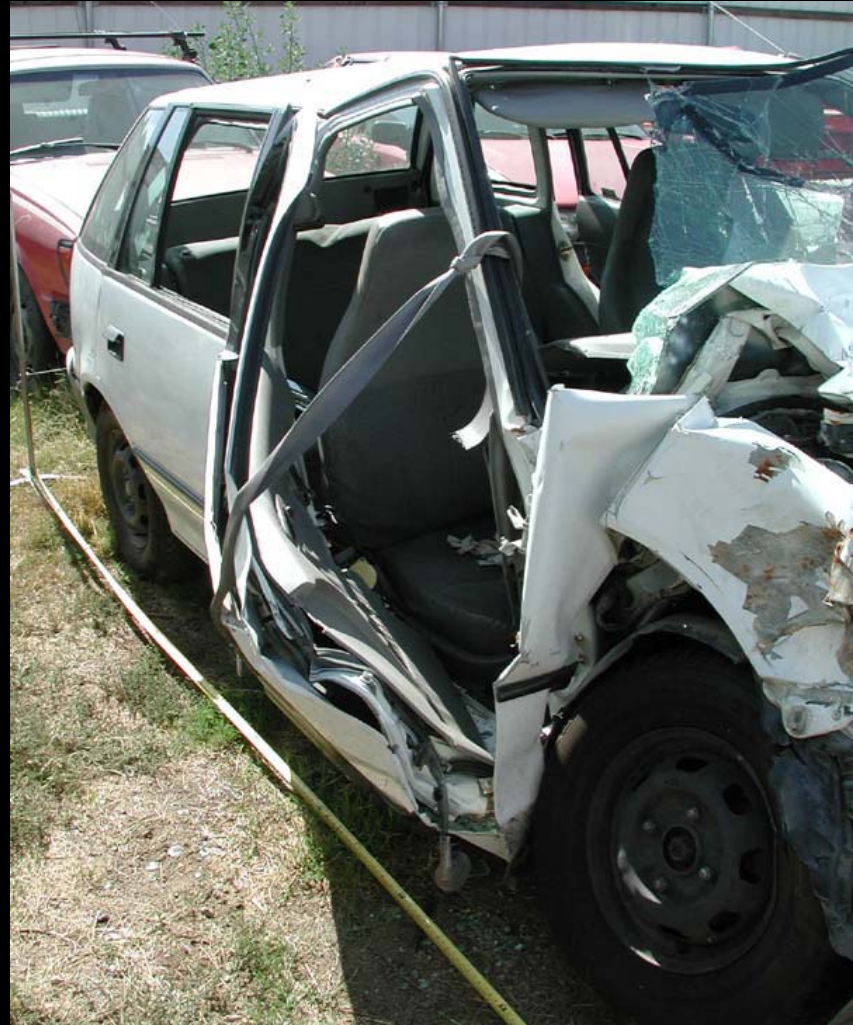
- ◆ Vehicles designed to absorb energy of crash
 - Crumple zones for frontal crashes
 - Reinforced steel for side crashes

94 Geo Metro

2001 Honda Civic EX

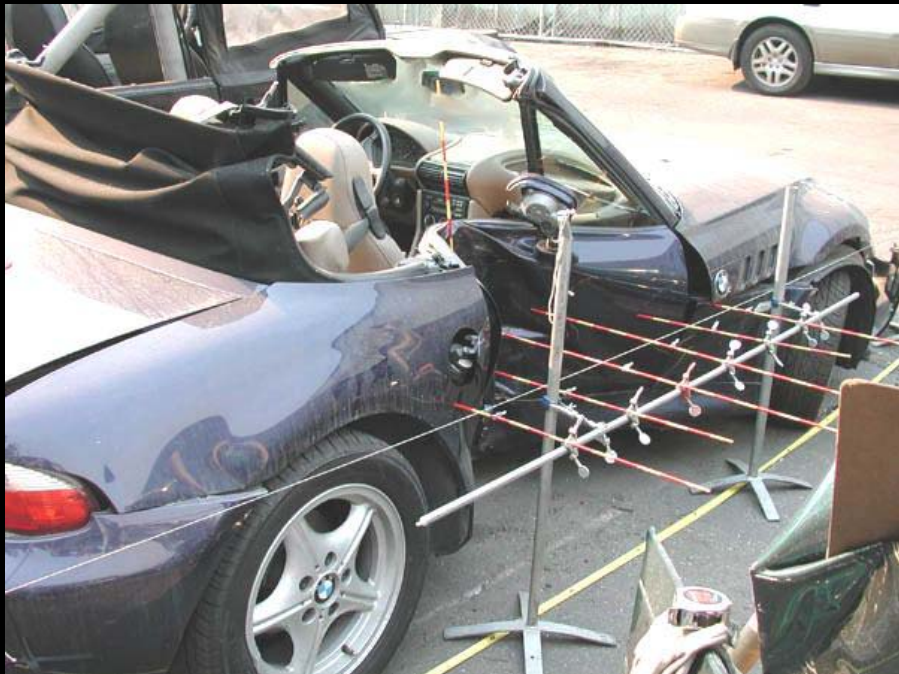
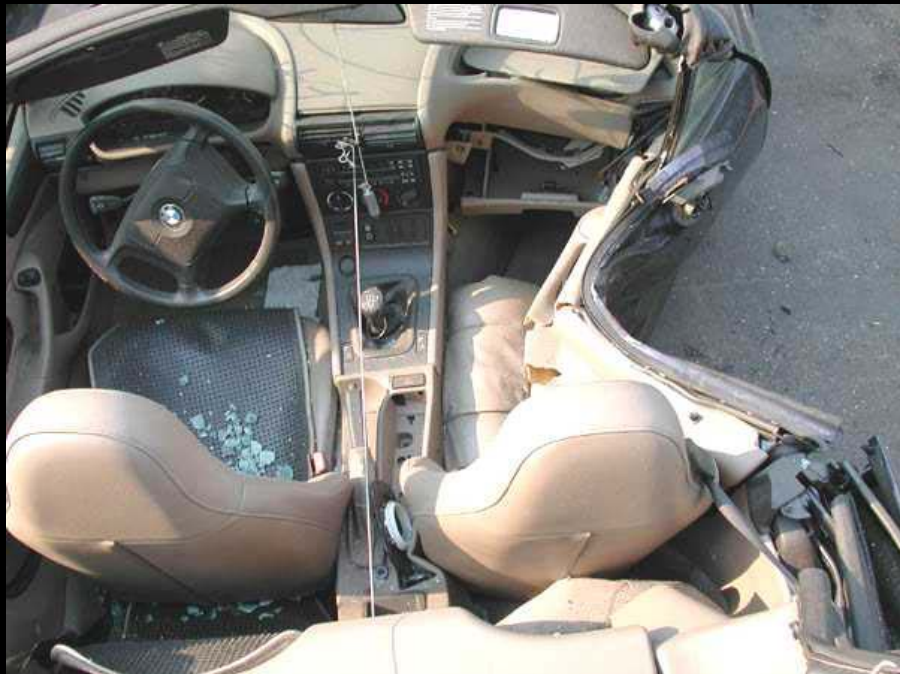
Deformation & Intrusion

- ◆ Indicators of crash severity
- ◆ Indicators of energy management
- ◆ Indicators of potential injury

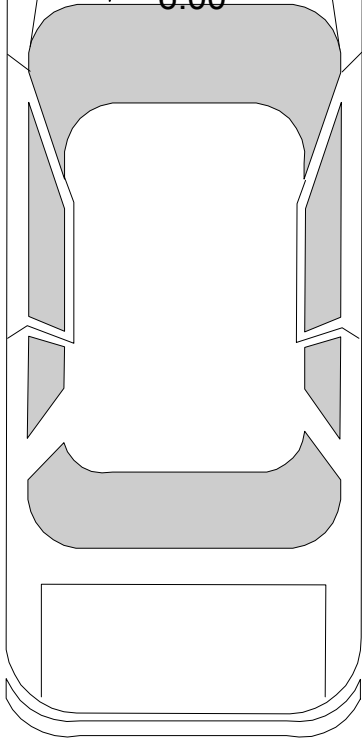
Applied To Point
Of Impact

Measured In
Degrees

Corresponds To
Clock Face

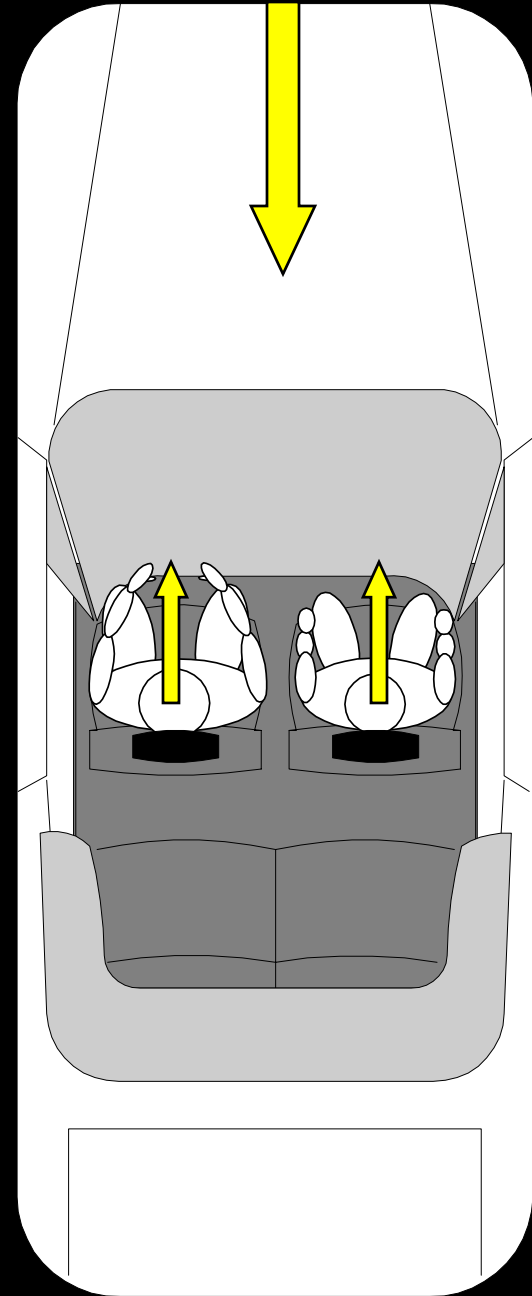
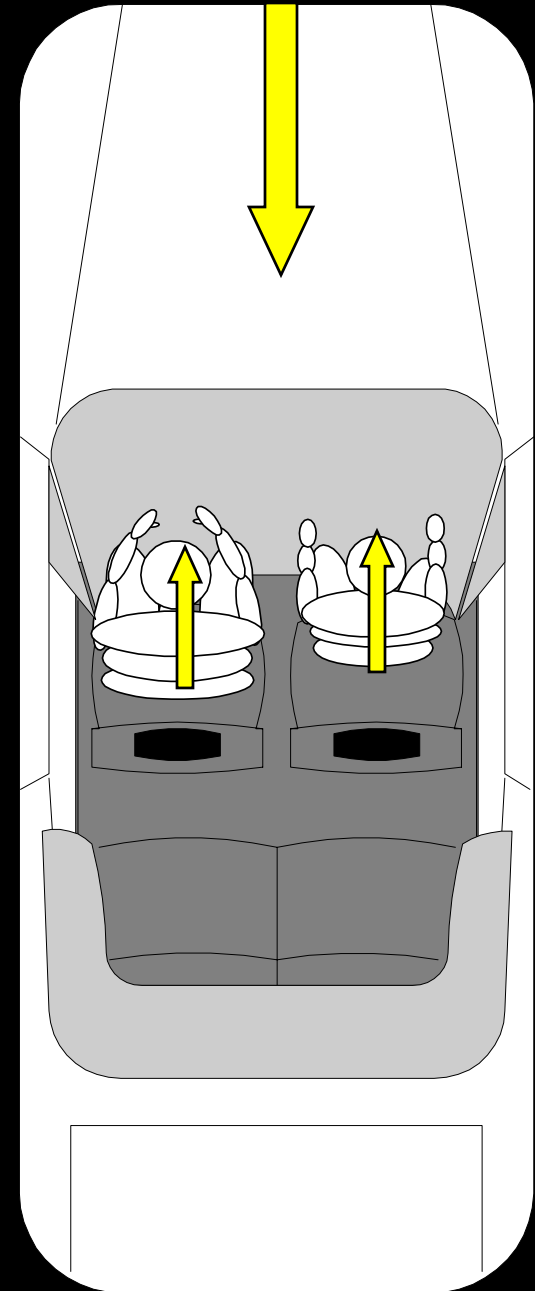
Zero PDOF

In a full frontal crash

Occupants move
opposite and parallel

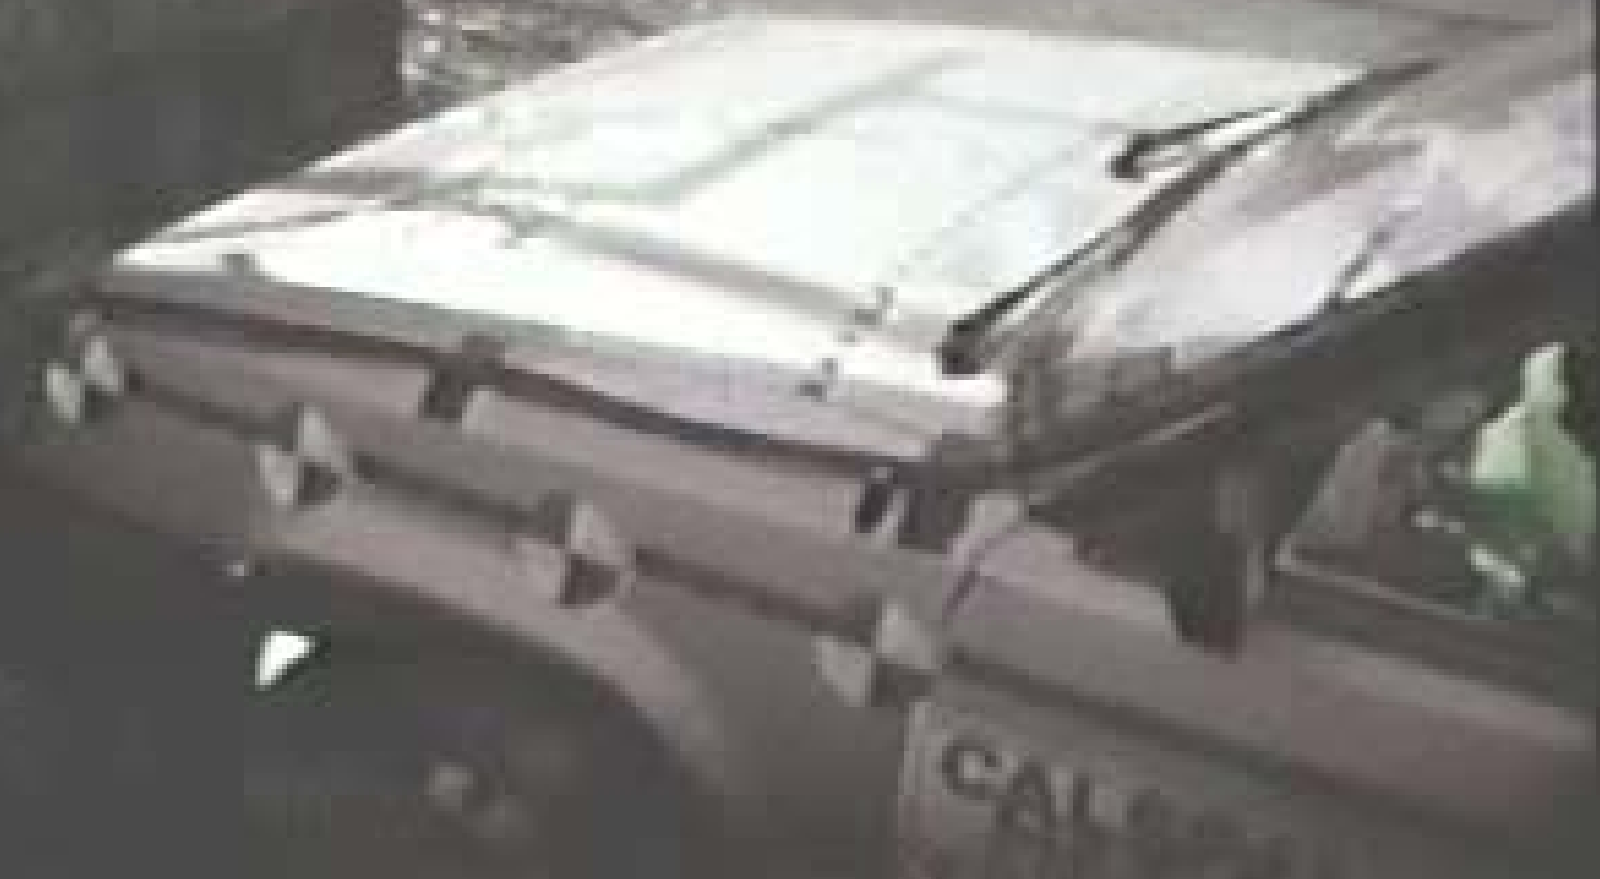
THE FOLLOWING 30 MPH FRONTAL
BARRIER IMPACT TEST WAS CONDUCTED
UNDER THE CONTRACT WITH THE NATIONAL
HIGHWAY TRAFFIC SAFETY ADMINISTRATION
BY MGA RESEARCH CORPORATION
BURLINGTON, WISCONSIN

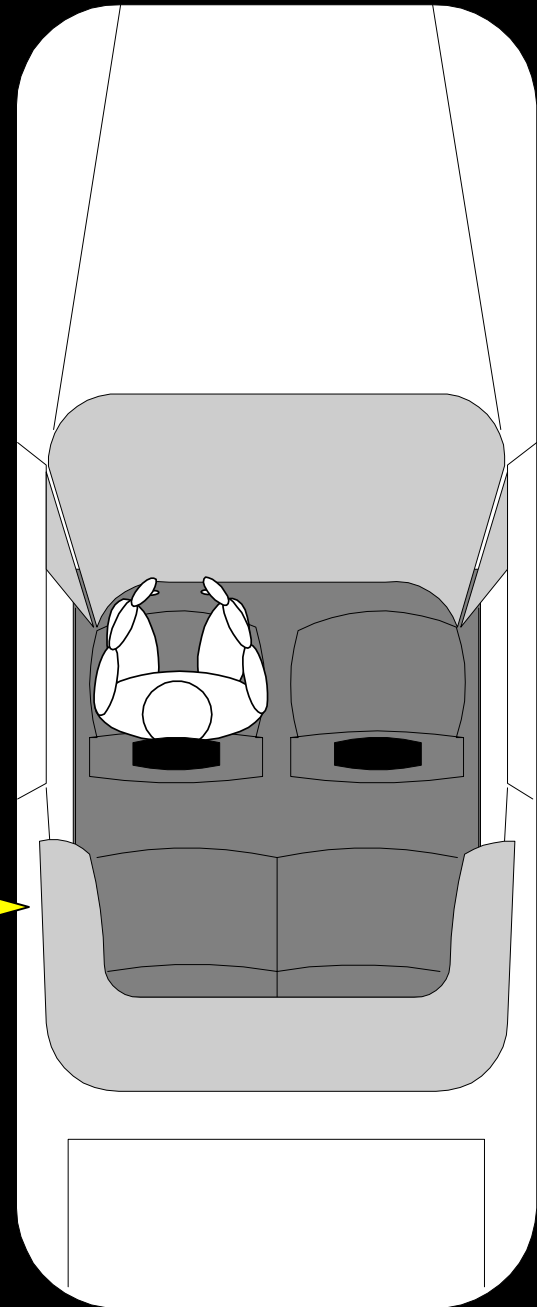
Occupant moves...

-90 degree PDOF

...opposite and parallel to
PDOF

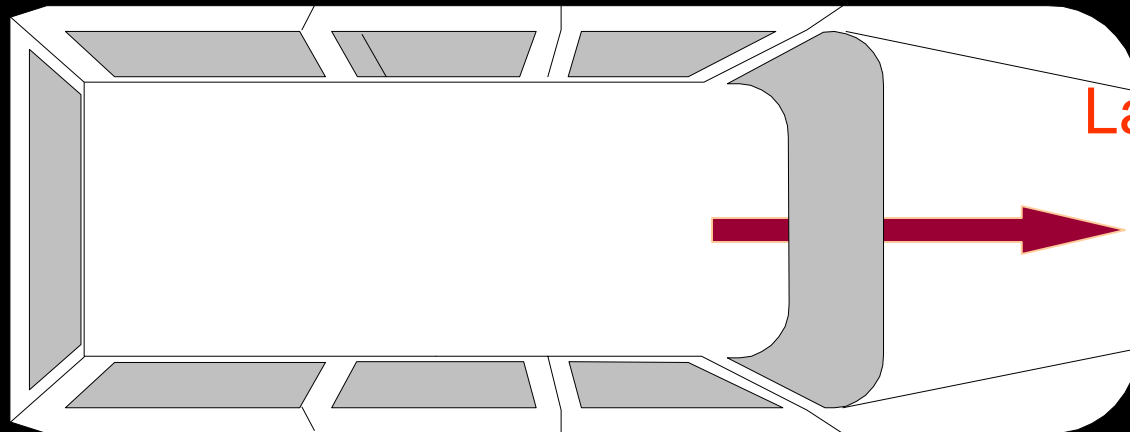
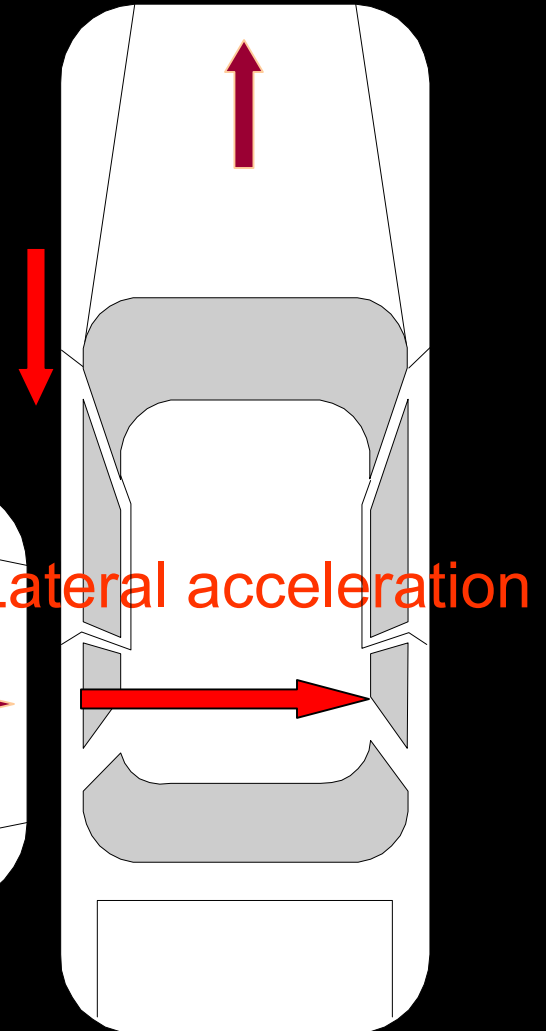
Because the subject vehicle has forward motion
it also has

rearward deceleration

Lateral acceleration

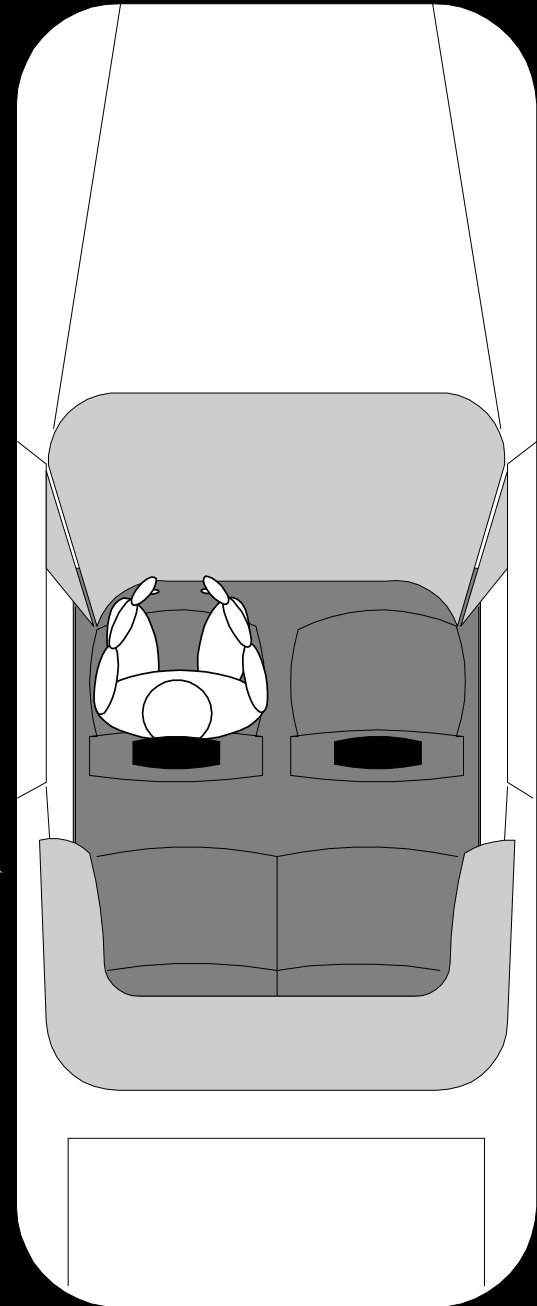
PDOF is: Resultant of forces acting upon the vehicle

PDOF -70 degrees

Opposite and parallel to PDOF

-70 degree PDOF

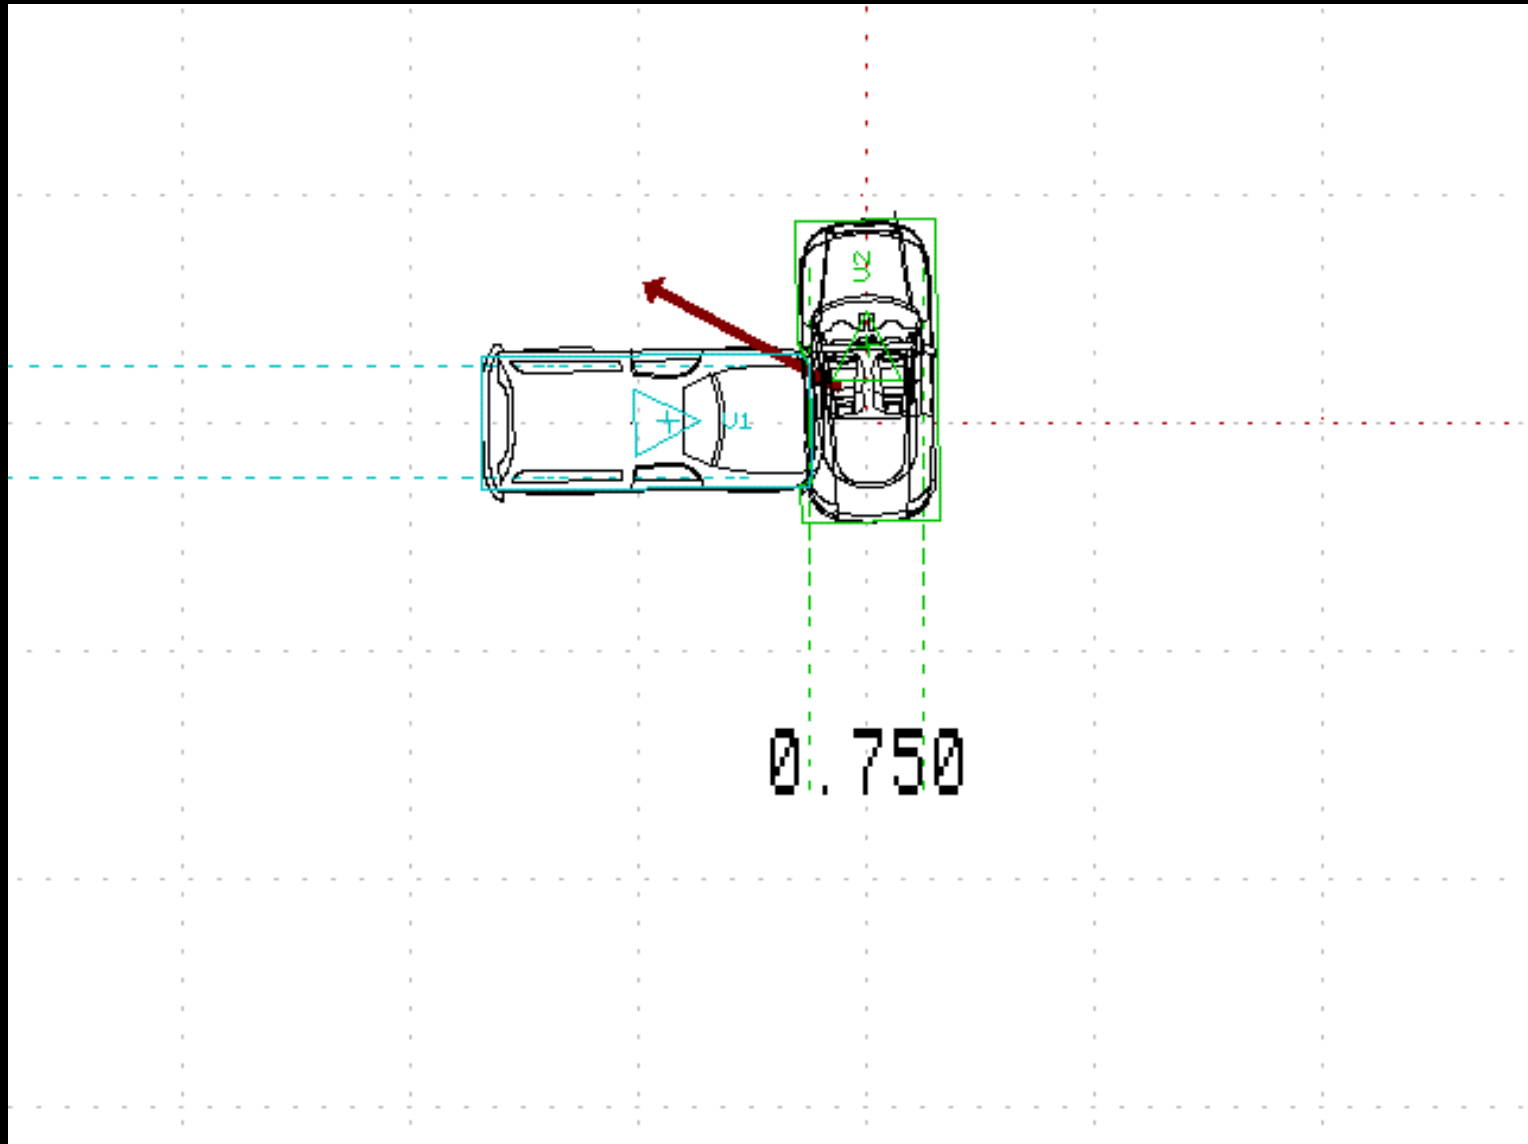
Primary Occupant Motion Vector

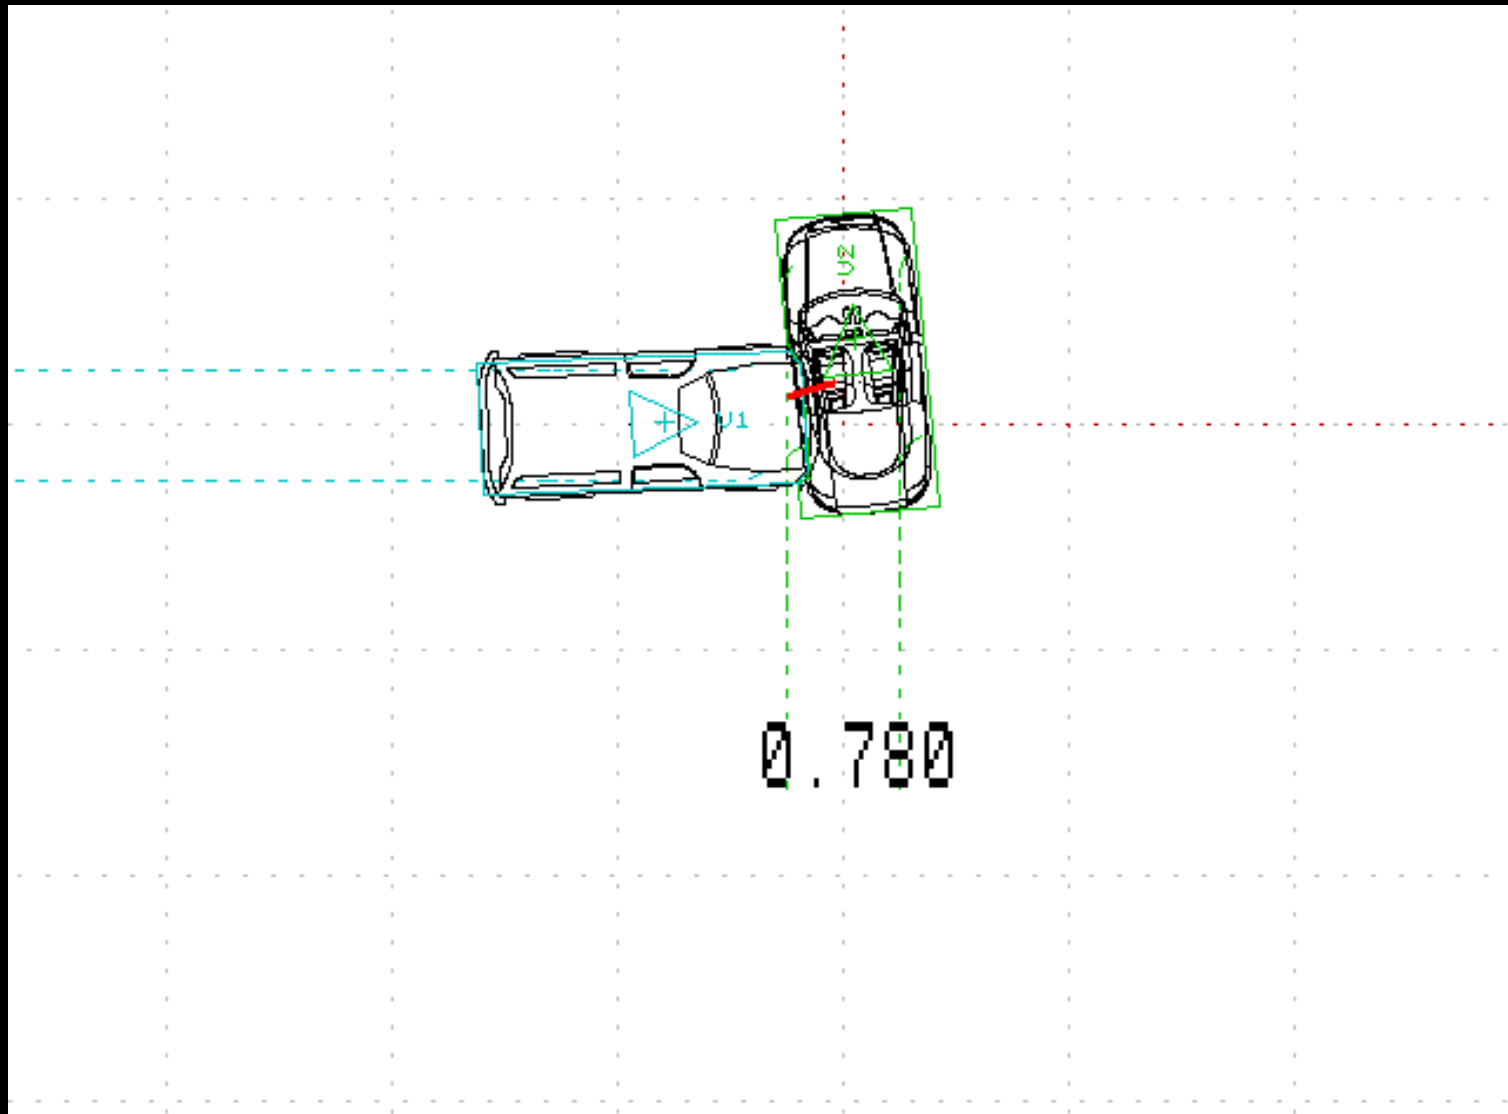
Secondary Occupant Motion Vector

2000 Buick LeSabre
Frontal Offset Crash Test
Deformable Barrier
64.3 kph (39.9 mph)
40 Percent Overlap
CF99015
June 24, 1999

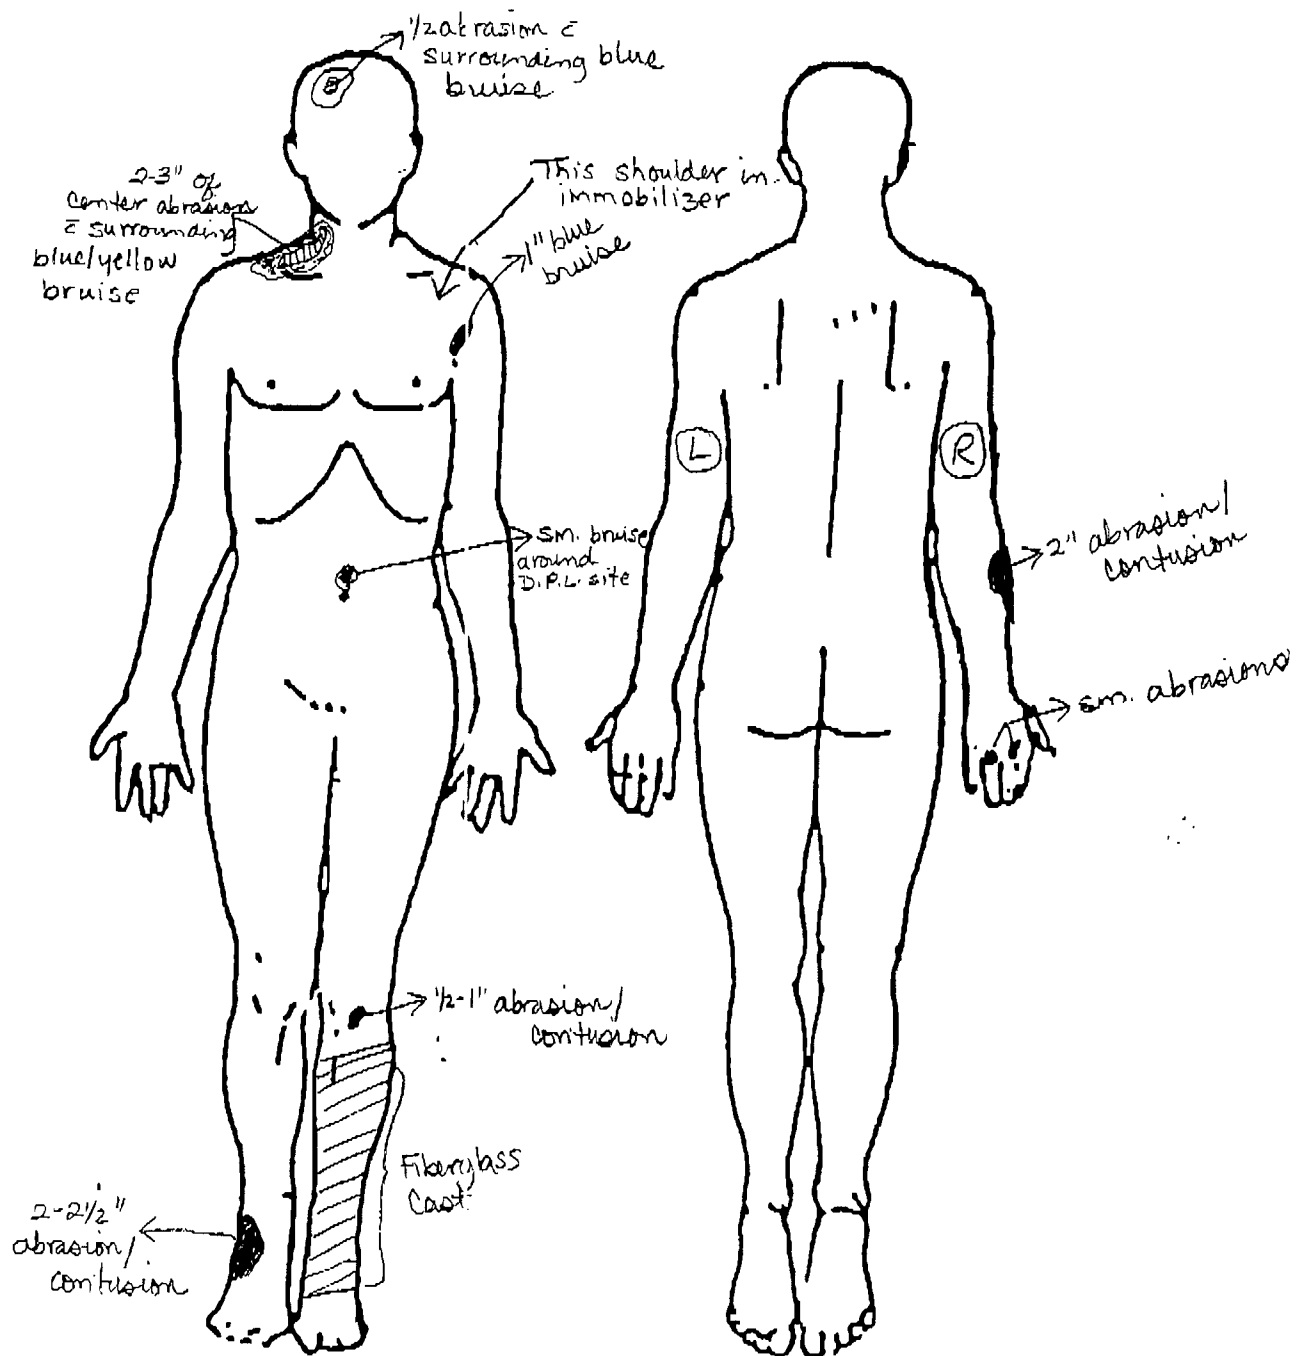
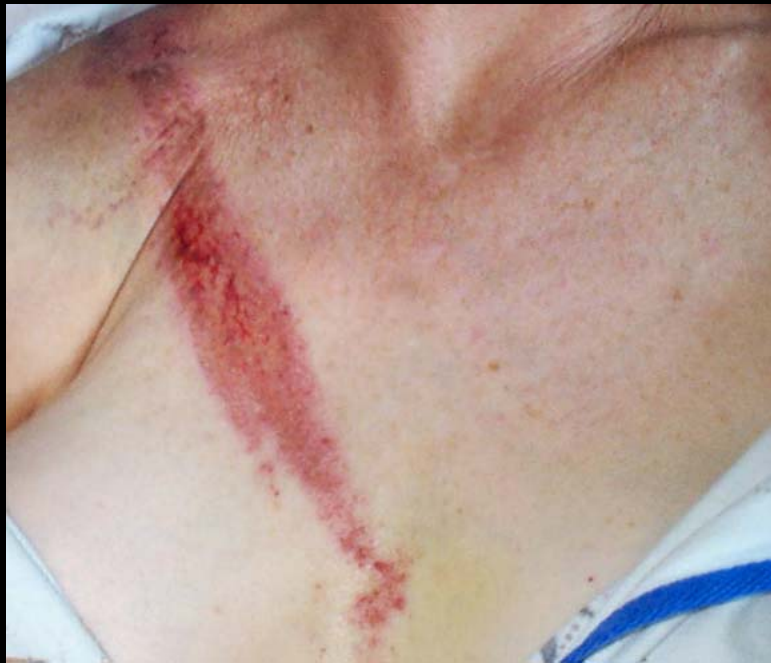
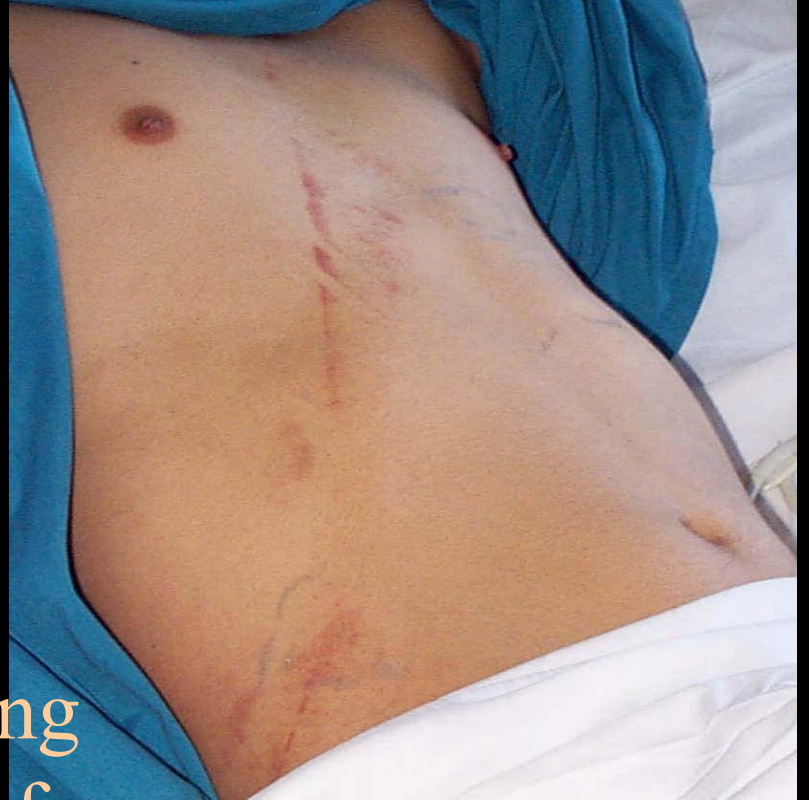
Diagram of Soft Tissue Injuries

- ◆ Description of all external lacerations, abrasions, contusions

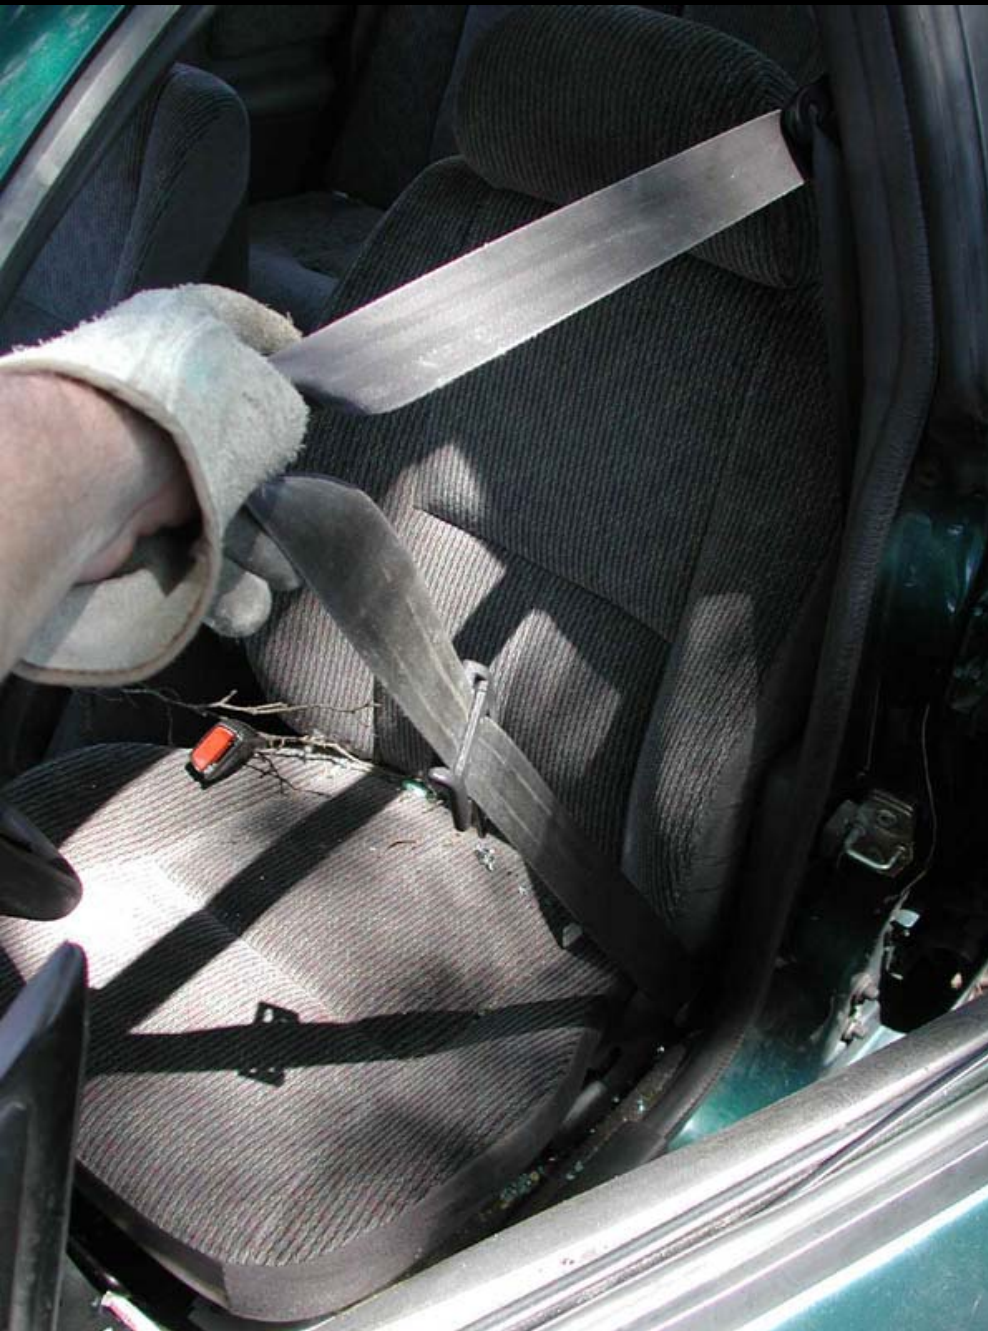
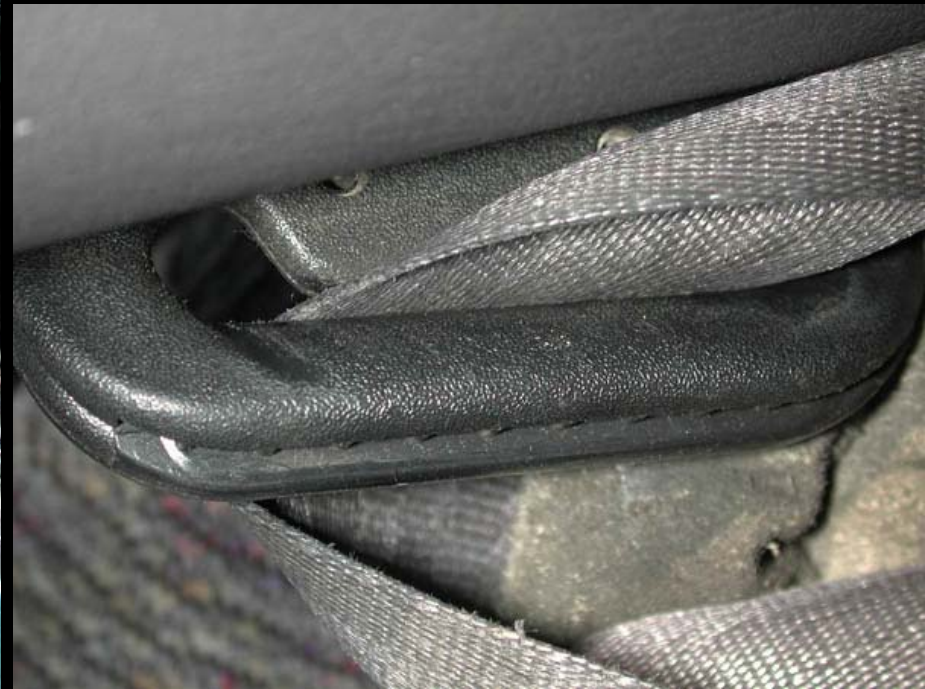
Physical Evidence of Seat Belt Use

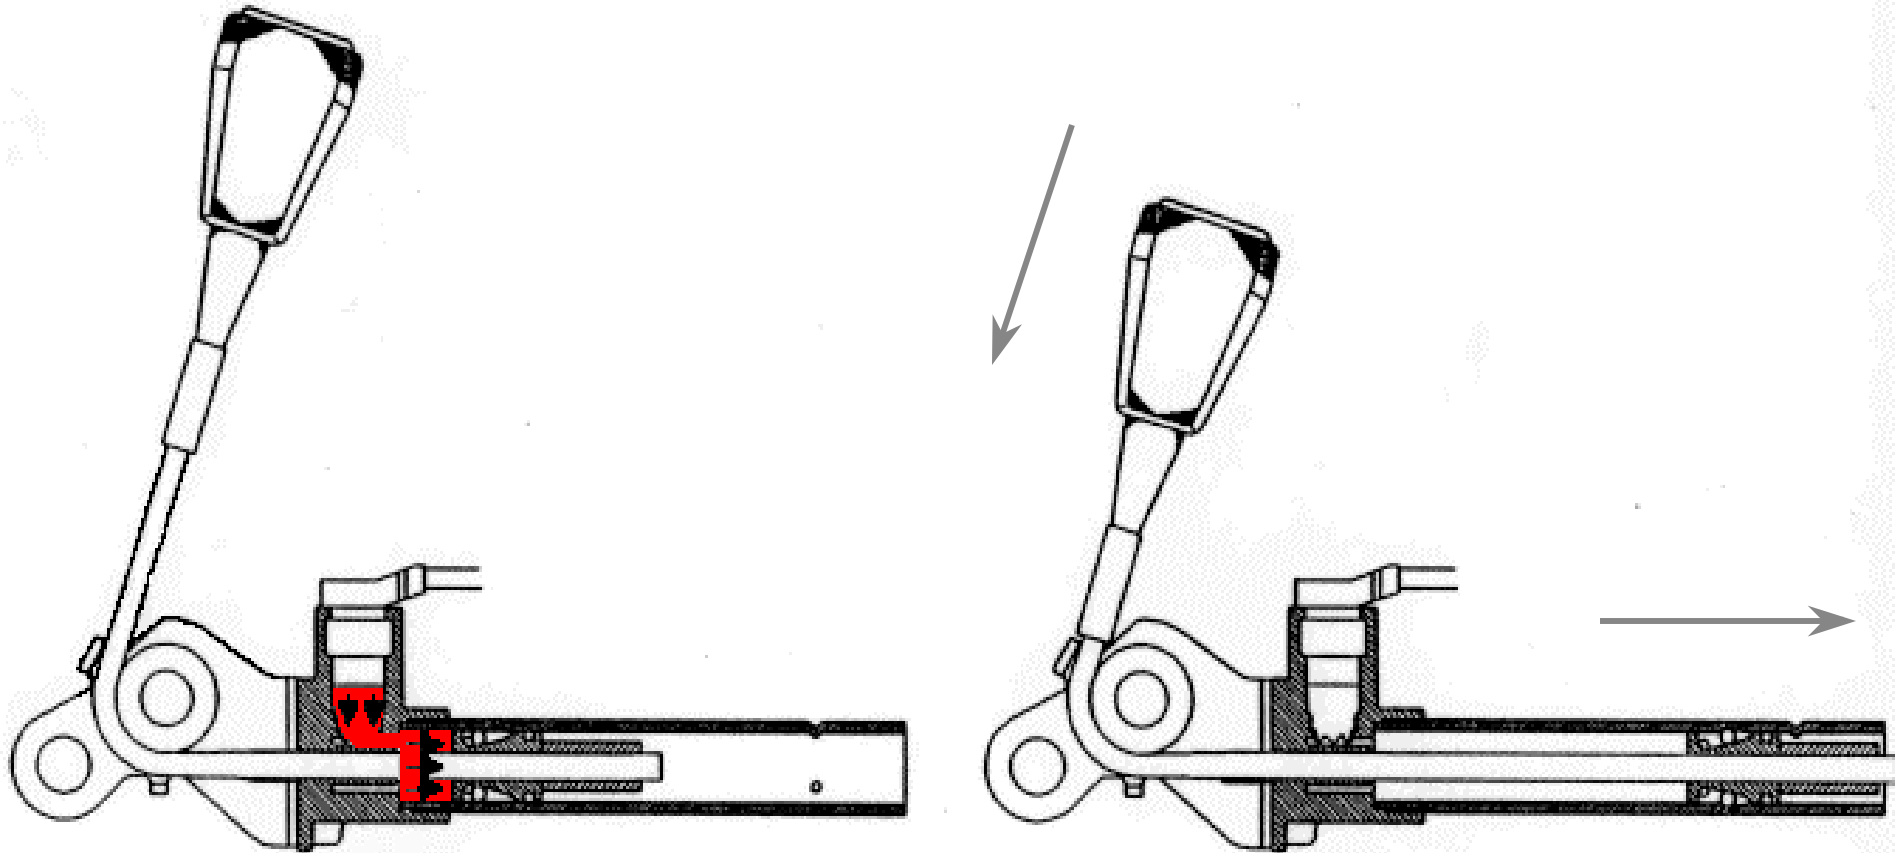
Buckle Pretensioner

IGNITION
DEPLOYMENT

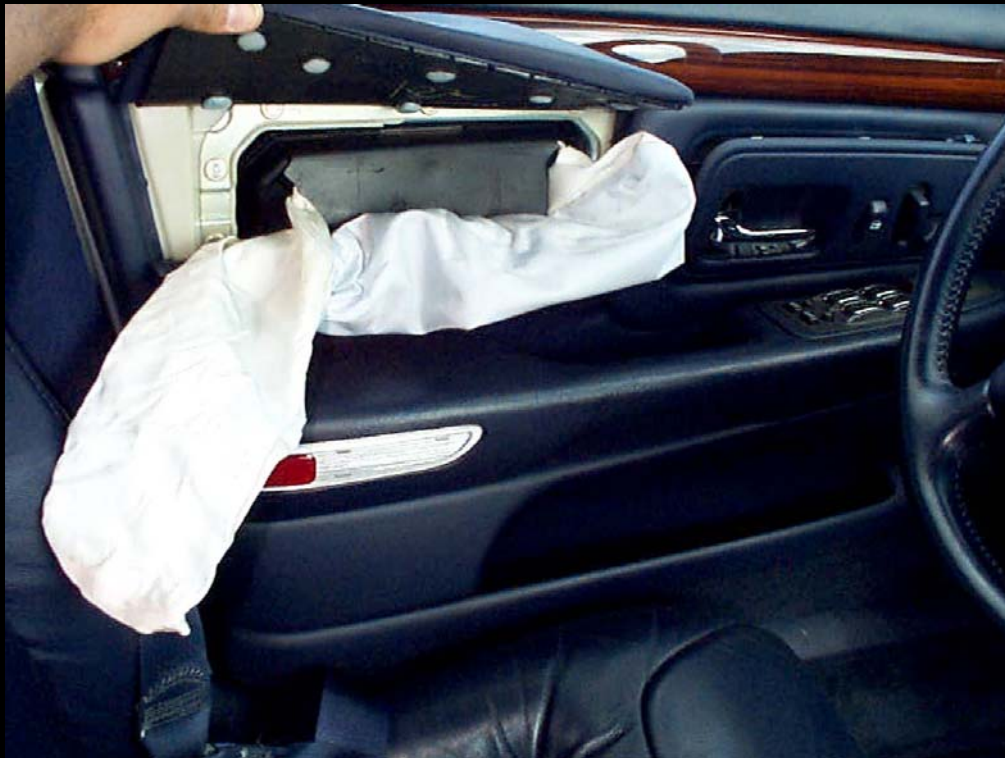
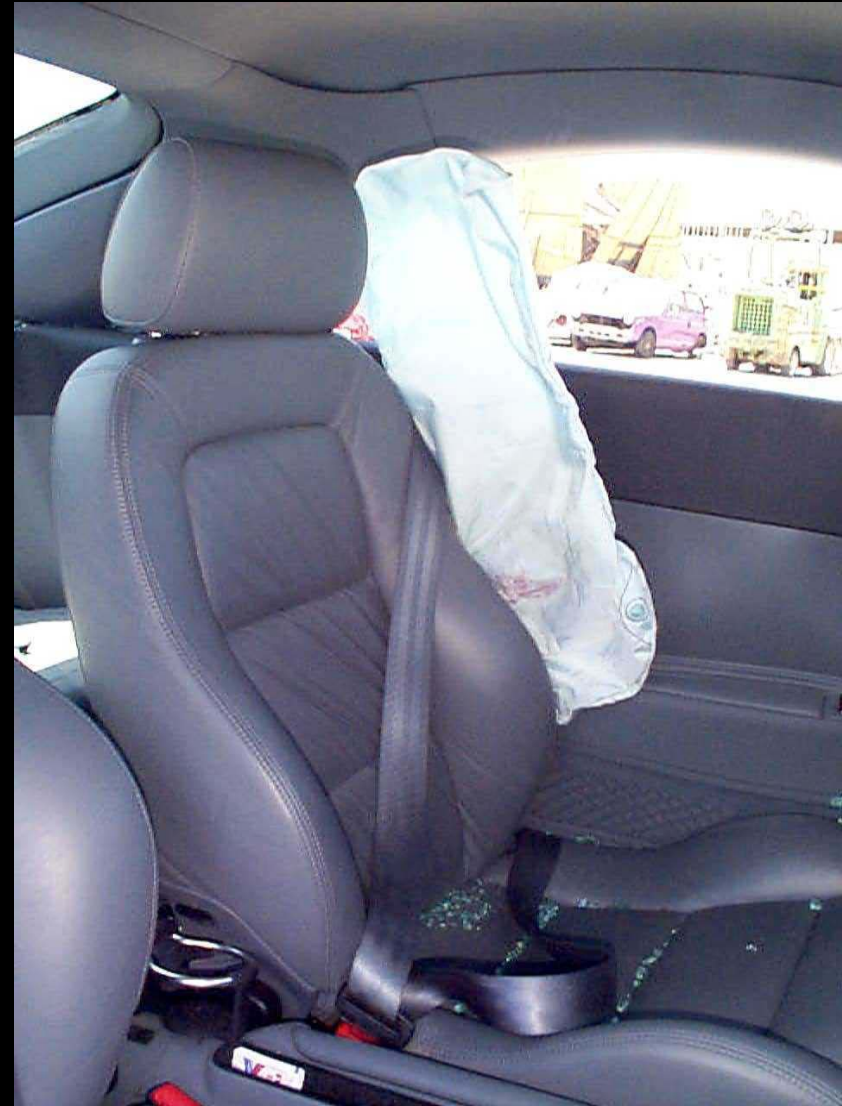
Side Air Bag Design

- ◆ Door mounted
- ◆ Seat mounted
- ◆ Roof rail mounted

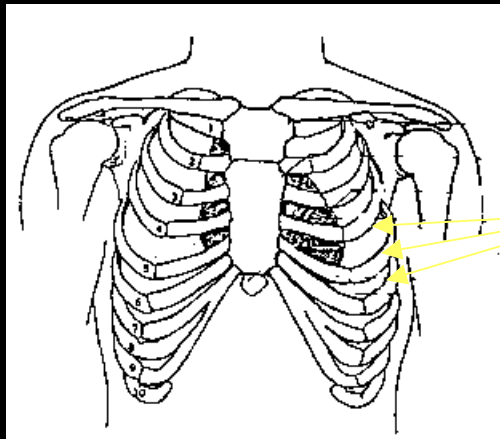
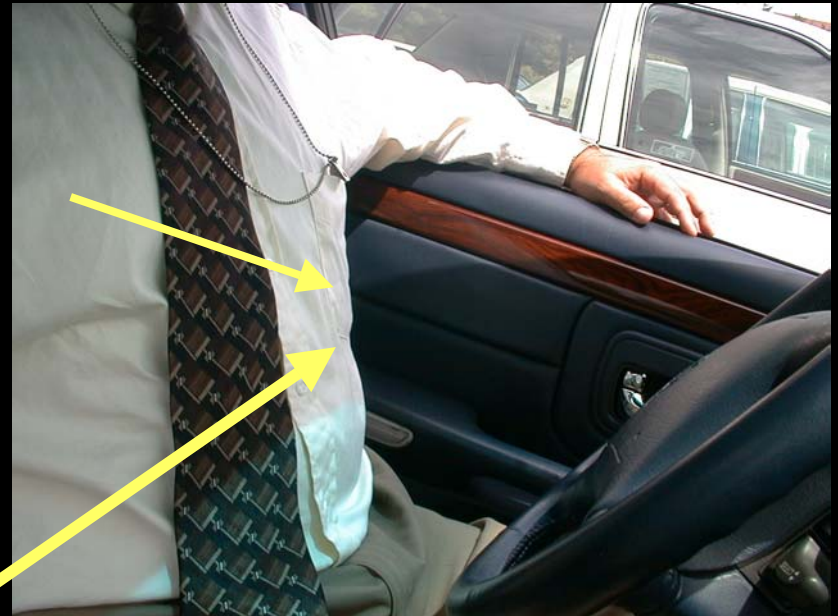
The Injury Mechanism

- Closed fracture 6, 7 & 8th left lateral ribs (3) with left anterior pneumothorax
- Abrasion left lateral chest
 - Crushing injuries are typically contusions
 - Swiping injuries are abrasions

- ◆ The side air bag is the injury mechanism.
